EVALUATION OF ENDODONTIC INSTRUMENTS AS RECEIVED FROM THE MANUFACTURER:
THE DEMAND FOR QUALITY CONTROL

*RONALD O SEGALL, DMD
**CARLOS E. del RIO, DDS
***JOHN M. BRADY, DDS, MSPH
****WILLIAM A. AYER, DDS, PhD

Two hundred seventy new files, reamers and Hedstrom files from three different manufacturers were evaluated for debris and defects. Statistical analysis of the new instruments showed that one company's instruments were cleaner than the other two but still contained defects. A standard for quality is proposed.

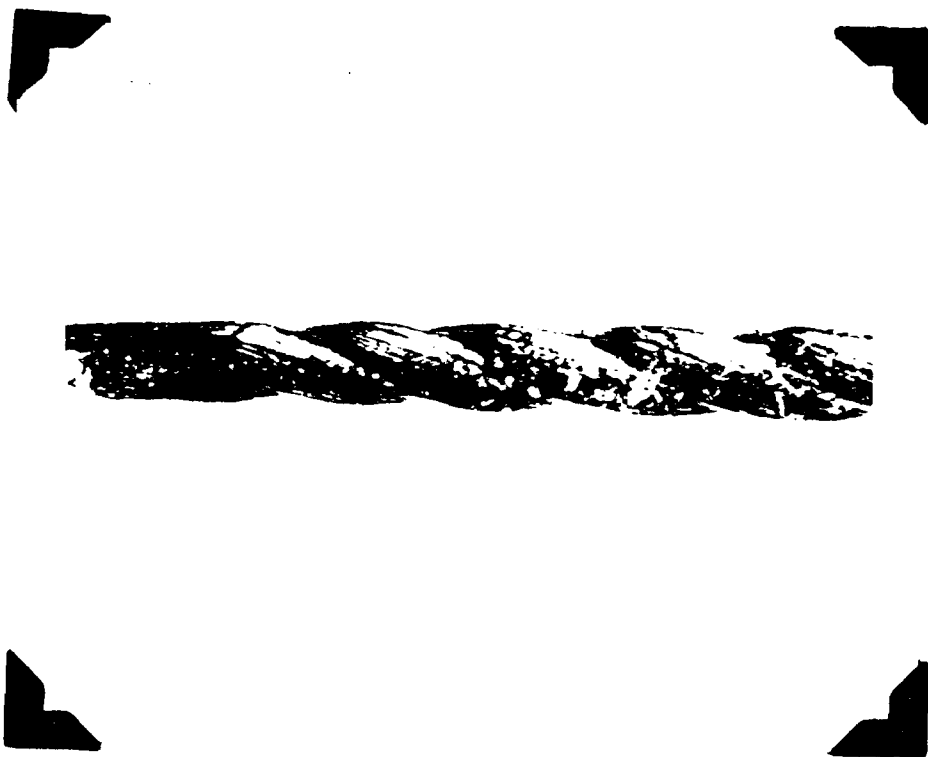
It was observed that company C's instruments had a much greater amount of colloidal debris and a grease or an oil film present (Fig. 2). Plastic from the handle was another common finding within the flutes (Fig. 3). Two Hedstrom files from two different manufacturers had a

- FIGURE 1 Instrument holder designed for orientation of the instruments.
- FIGURE 2 Colloidal debris, grease or oil film found on new instruments (orig mag X37.5)

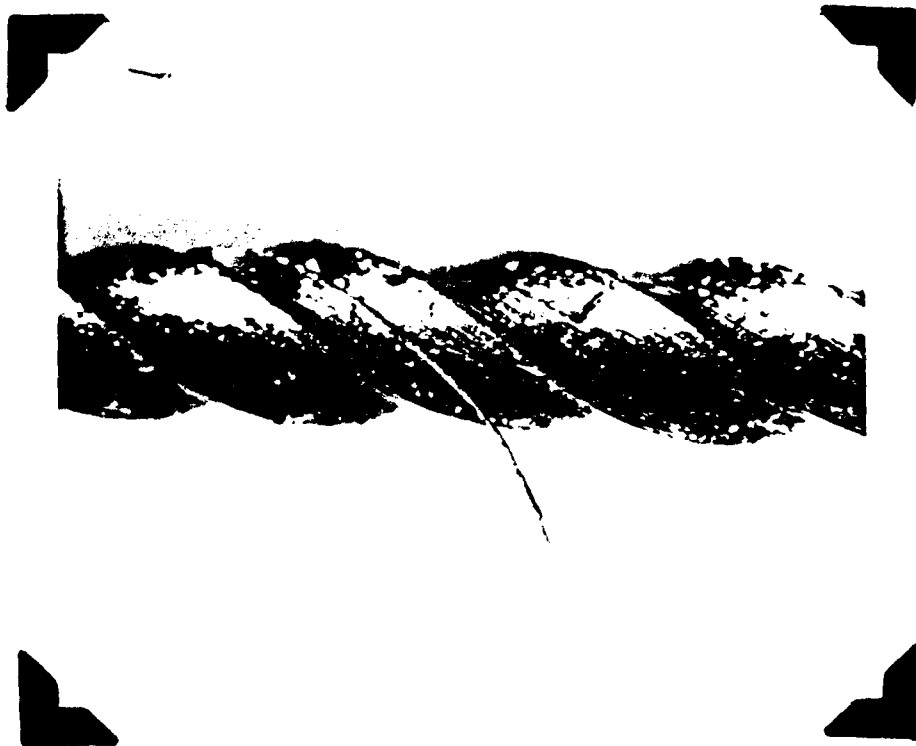
Metal spurs appeared to be frequent in all three companies, although more so in files than reamers or Hedstrom files (Fig. 6). Hedstrom files frequently had barbs at their tips (Fig. 7). Other common defects in the instruments were sections of flutes which were either observed to be unwound slightly or wound too tightly. This was seen commonly with the files (Fig. 8). Comparison of similar instruments from the three different manufacturers showed noticeable differences in the space between the flutes and the apparent sharpness of the instruments (Fig. 9).

Evaluation of 270 files, reamers, and Hedstrom files directly out of their packages demonstrated the need to cleanse these instruments prior to being autoclaved. Unfortunately cleansing is extremely difficult and quite time consuming. The plastic and metal spurs represent perhaps the most serious debris. Both have the potential to cause spontaneous blockage of fine radicular canals. Eventual corrosion of the dislodged metal spurs may cause complications; the possibility of which have not been fully investigated.

- FIGURE 5 File with epithelial cells debris (orig mag X37.5).
- FIGURE 6 Frequent metal spurs such as the one shown here were found in new files (orig mag X37.5).

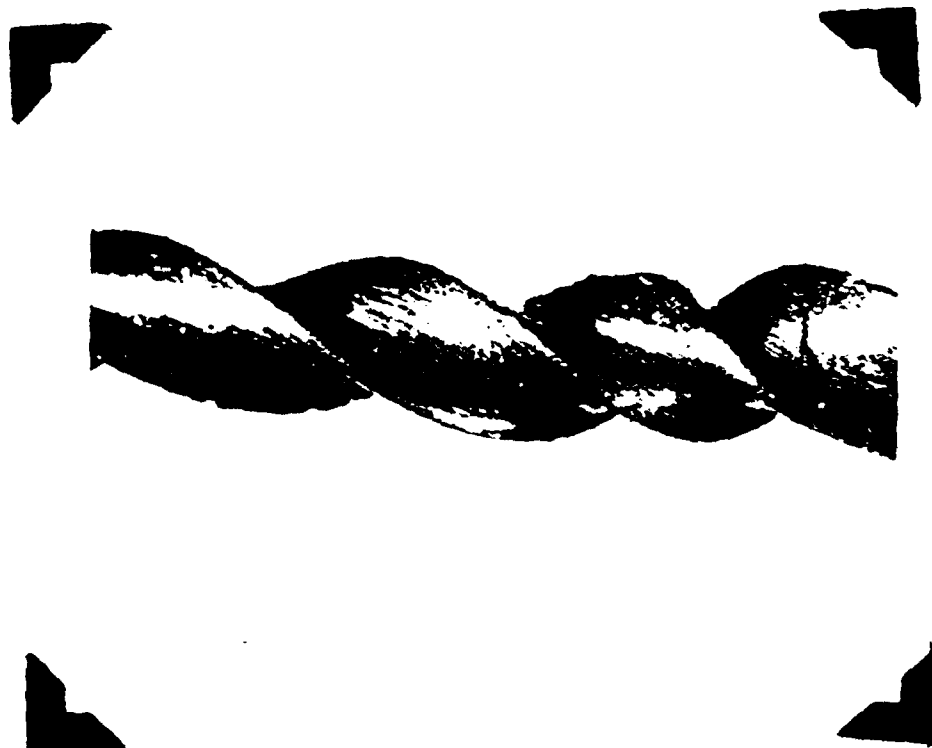
- FIGURE 8b File with too tight of a twist which is an area of possible fracture (orig mag X37.5).
- FIGURE 9 The comparison of reamers from three different manufactures. Notice the variations in flute design (orig mag X9).
*Company A; "Company B; 'Company C.

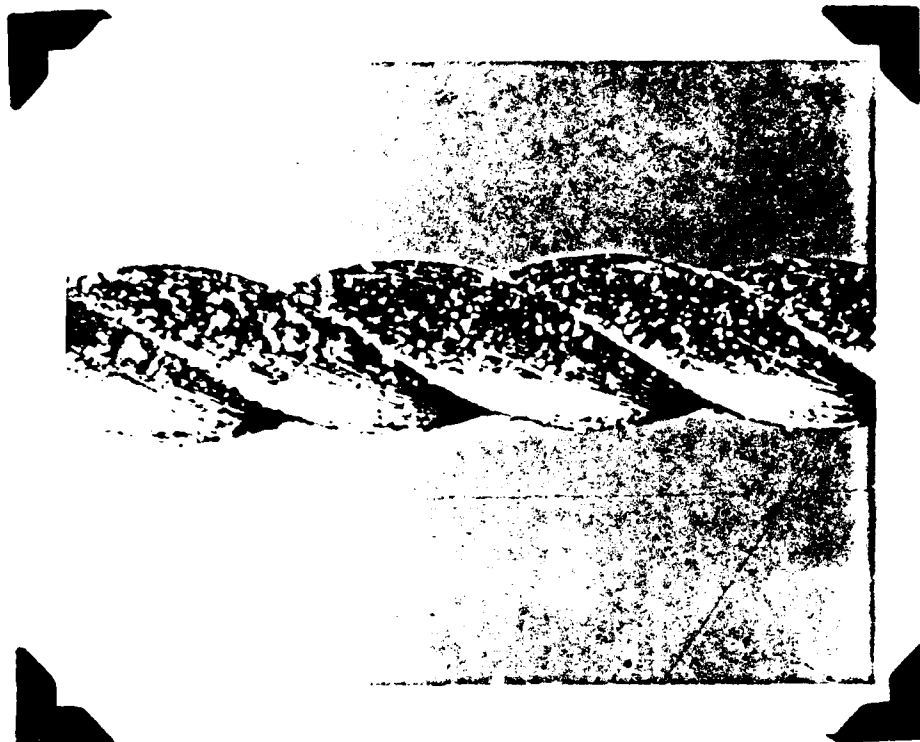
plastic within the flutes. It did not accomplish this but left the flutes coated with salt crystals (Fig.10).

- FIGURE 10 The quantity of salt crystals deposited on the surface of a file during sterilization in the hot salt sterilizer (orig mag X37.5).
